# Architectural Conservation of an Amun Temple in Sudan

Tracey Sweek\*, Julie R. Anderson† and Satoko Tanimoto\*\*

The excavation of an Amun temple commenced in Dangeil, Sudan, in 2000 under the directorship of Drs Salah Mohammed Ahmed of the National Corporation for Antiquities and Museums, Khartoum and Julie R. Anderson of the British Museum, London. Dangeil is located to the south of the 5th Nile cataract. In 2008, a preliminary visit was organised to initiate a conservation programme and trials to the architectural fabric of the temple. The materials used in the temple's construction include mud brick, fired brick, lime plaster and sandstone. During the subsequent seasons adjustments and evaluations of the previous years' completed trials have been assessed. This case study outlines the progress of the conservation programme to date.

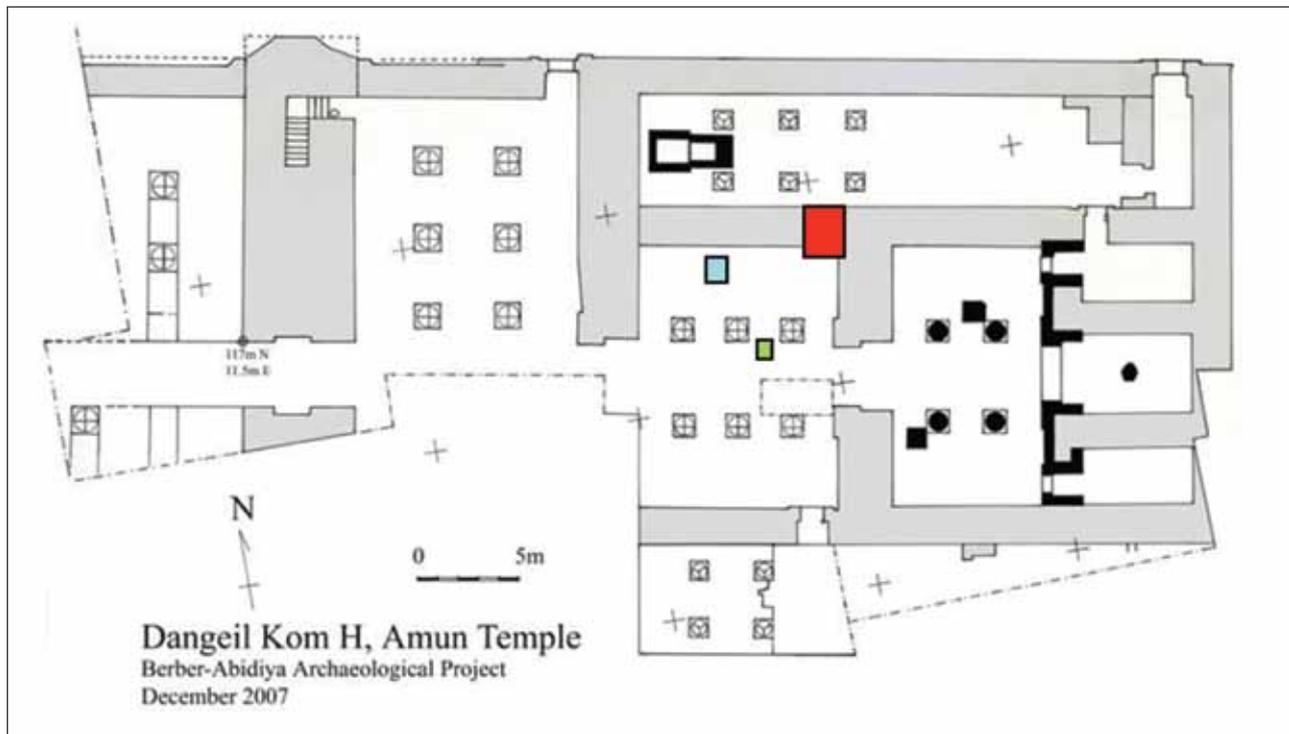
**Fig. 3:** Plan of the temple (Drawing by Anderson 2007).

The temple (48.5 x 33.5 m) is orientated east-west, in the desert on the edge with cultivated land, with the entrance facing the Nile. Most walls are a metre wide and preserved to a standing height between 1.5 and 3 metres. The basic unit of measurement used in construction was the Egyptian cubit (*c.* 52.3 cm) and it is evident that the structure was laid out precisely. The measurements reveal clear harmonic proportions, symmetry and regular architectural planning principles (Anderson 2009; Anderson *et al.* 2007; Anderson and Salah 2010a, 2010b, 2009, 2008, 2006-7, 2006a, 2006b, 2006c, 2002a, 2002b, 1998-2002).

The areas selected for testing included a range of the site's architectural elements; an area of the missing sandstone floor; the lime-plastered sandstone walls; the capping and rendering of the exposed fired brick walls (red) and the plaster-rendered brick columns (blue/green) (**figure 3**).

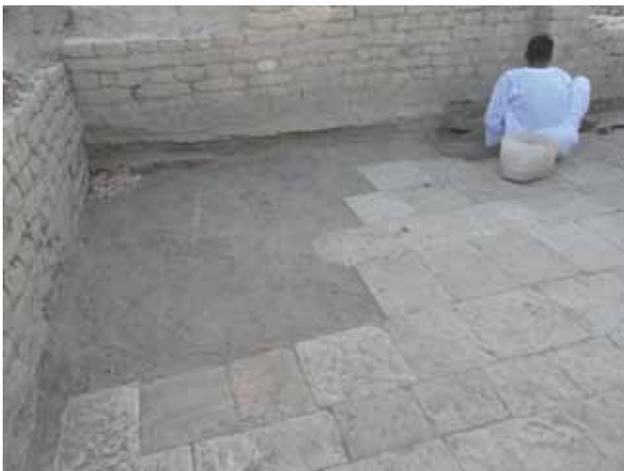
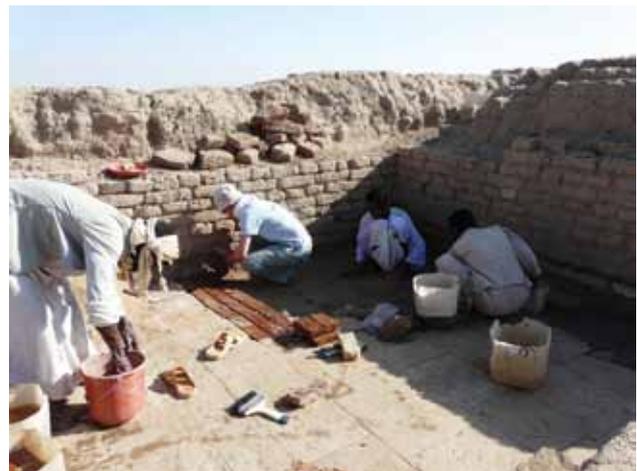
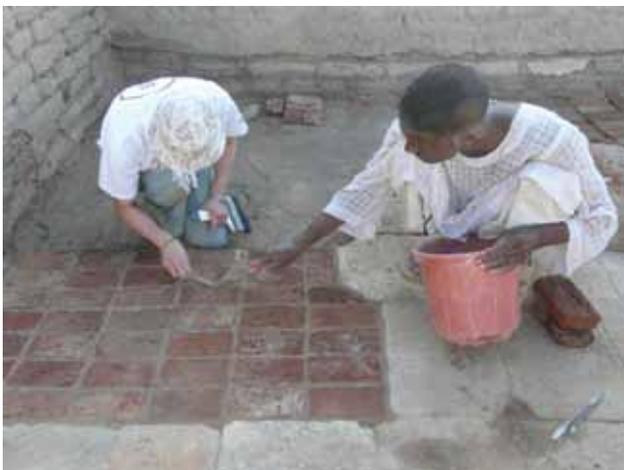
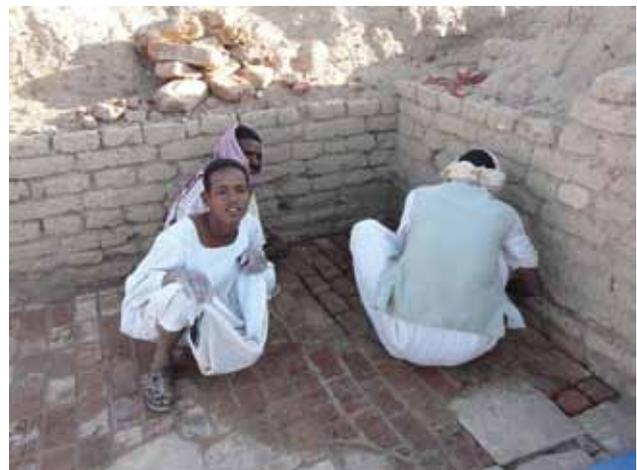
**Fig. 4:** Area of missing sandstone floor.

**Fig. 5:** Bedding the brick infill.

**Fig. 6:** Pointing the bricks.

**Fig. 7:** Finished floor area.

With a small team of local workers to train, a missing section of sandstone floor was the first area selected. The intention was to fill the missing area with fired bricks. Sand and soil were removed and the area was levelled to allow for a bedding mix and a brick depth to be laid. The area was well-damped and the bricks soaked to avoid rapid drying of the bedding mortar (Lee and Wood 2009). In this climate it was imperative to plan the activities of the day. When possible, work was carried out in shady areas and

in the coolness of the early morning. It was important to avoid working in areas directly under the midday sun and it was essential to keep the lime mortar work covered with tarpaulins. This allowed the mortar to cure\* slowly and in a controlled way. Retaining the moisture in the bricks and mortar assisted the pointing\* (**figures 4 to 7**) (Lee and Wood 2009).

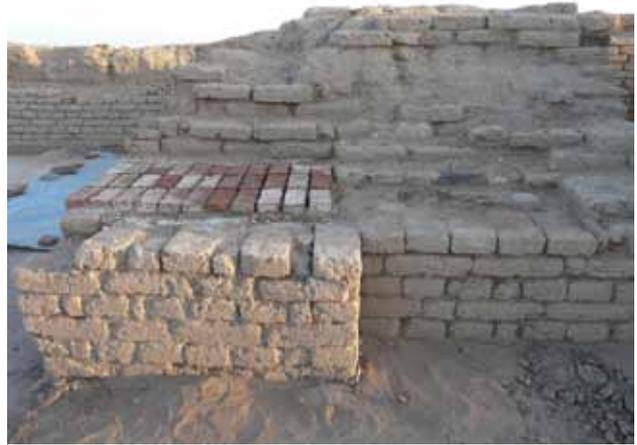
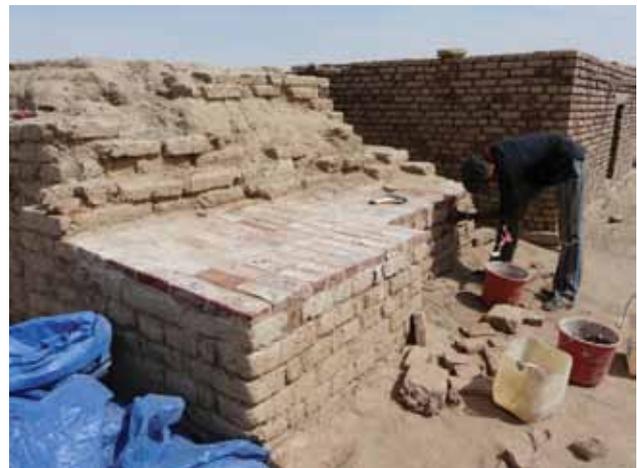
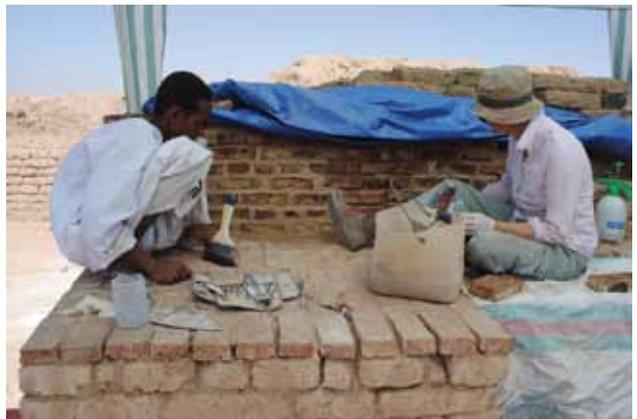
**Fig. 8:** Capping exposed walls

**Fig. 9:** Finished capped wall

**Fig. 10:** Building up the vertical wall

A similar practice and approach was followed in other trial areas; bedding with combinations of lime mortars; raking out and removal of excess soil; pointing. For the wall capping and brick column, a render was applied to cover the top of the new bricks (**figures 8 to 10**).

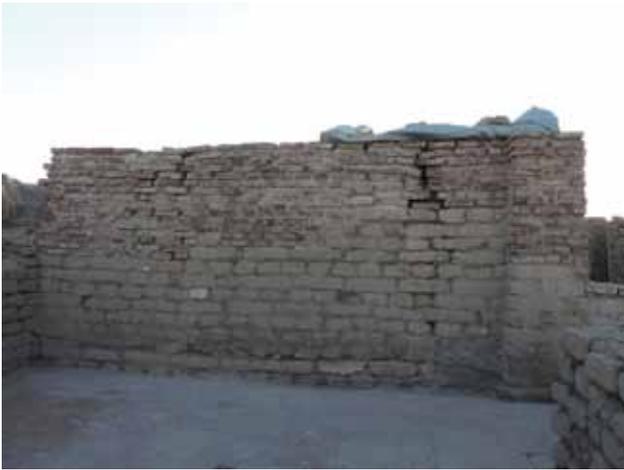
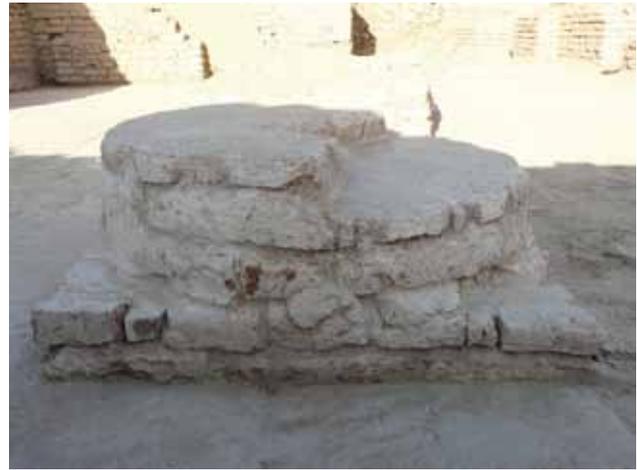
**Fig. 11:** Failed pointing to capped wall.

**Fig. 12:** Failed lime render to brick column.

Subsequent seasons have allowed evaluation of the previous years' work; this facilitates continuation of work in the trial areas and adjustment of methods and treatments, if necessary. Regrettably, it was noticed that there had been some failures to the wall capping and rendered areas. The lime pointing to the brick wall capping and the brick column had been washed away by seasonal rains (**figures 11 and 12**).

The same methods as in 2008 were used. Whilst it was felt that the workmen required more training in building with and using lime, it was clear that this was not the key reason for failure. The foremost reason was the weakness and absence of lime in the mortars as shown by the scientific analyses of the mortars (see below).

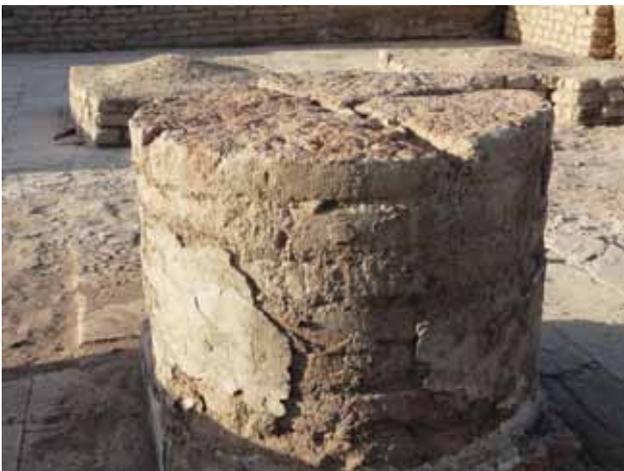
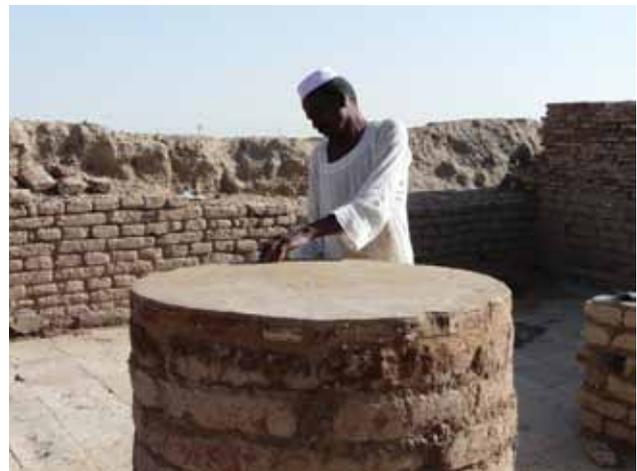
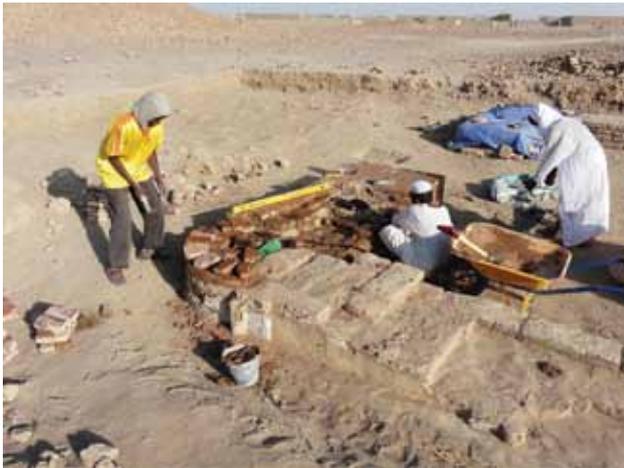
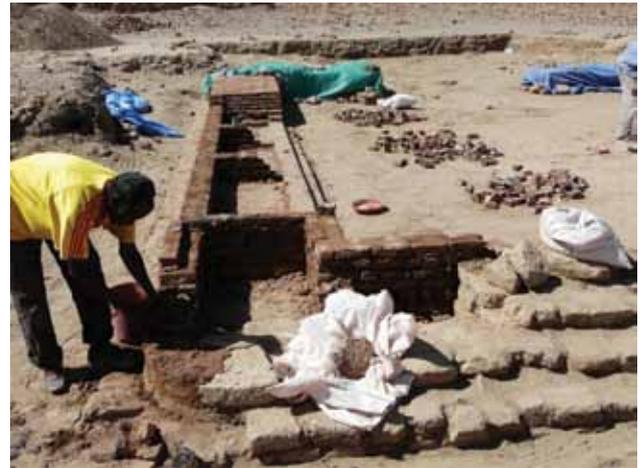
**Fig. 13:** Brick and lime rendered column, 2011.

**Fig. 14:** Capping render to column, 2011.

**Fig. 15:** Brick capping the Kiosk walls, 2011.

**Fig. 16:** Brick capping the Kiosk walls, 2011.

However, the work continues to progress and further areas of the temple are selected for capping (**figures 13 to 16**). During the 2011 season we have been fortunate to employ an architectural builder from Khartoum who has experience in working with lime. He has been able to lead the local workmen and his local knowledge has helped enormously with the purchase of materials including lime fure.

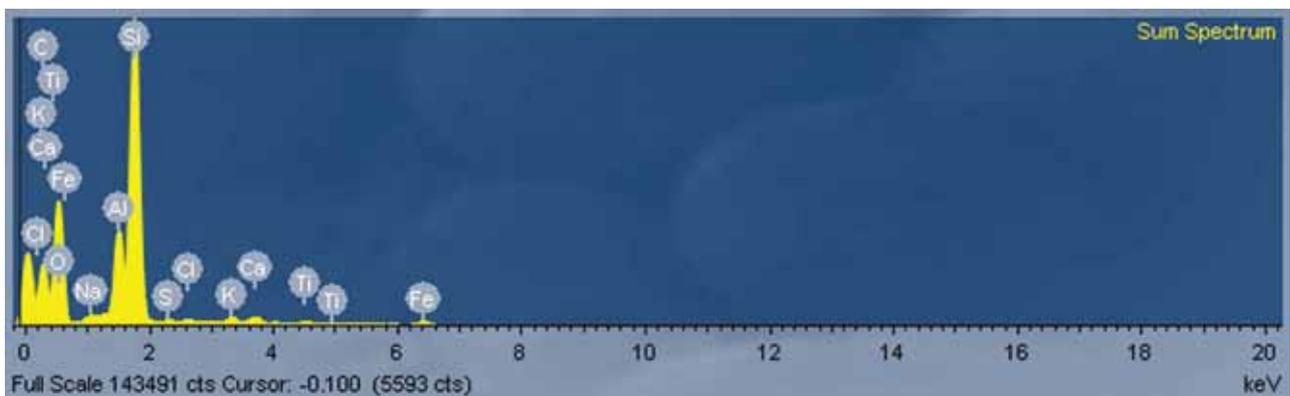
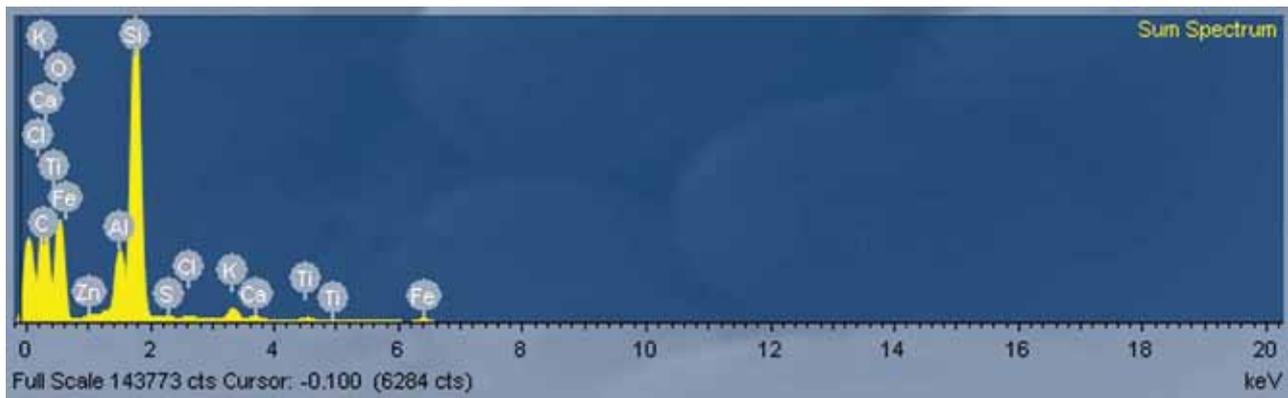
**Fig. 17:** Elemental composition of sample II prepared at Dangeil.

Fig. 18: Elemental composition of sample IV prepared at Dangeil.

tor in a Hitachi S-3700N variable pressure scanning electron microscopy (VP-SEM: 20 kV, 30 Pa). Energy dispersive X-ray (EDX) microanalysis was conducted on all uncoated cross-sections to analyse and map their elemental compositions. The analyses revealed that the lime content, as indicated by the calcium (Ca) peak, was negligible in two mortar samples prepared in Sudan (samples II and IV, **figures 17 and 18**).

Museum. It was hoped that these analyses would give an indication of the lime content in the mortars being used and explain the reason for failure. In the preceding season, purchasing lime appeared to be a lottery, when, as already suggested, one bag transpired to be a casting plaster (**figures 17 to 21**).

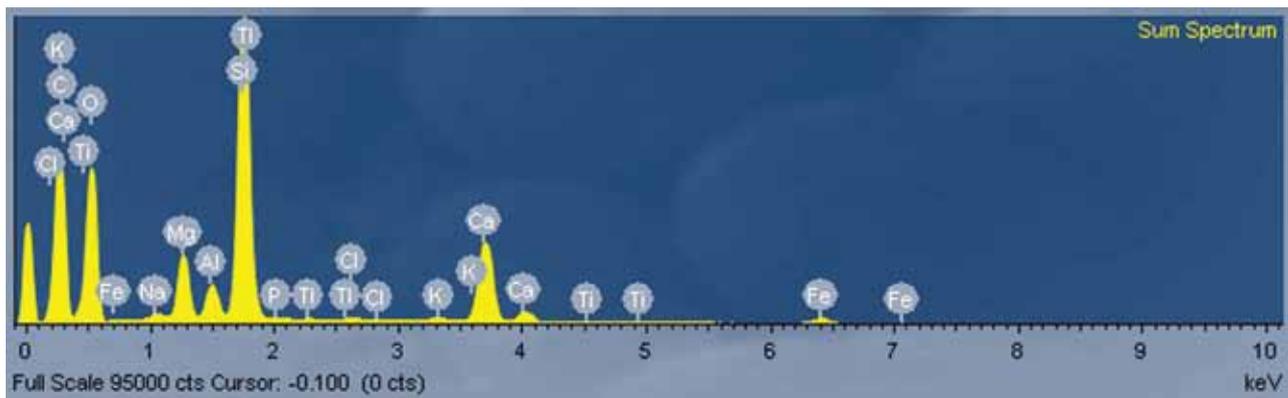
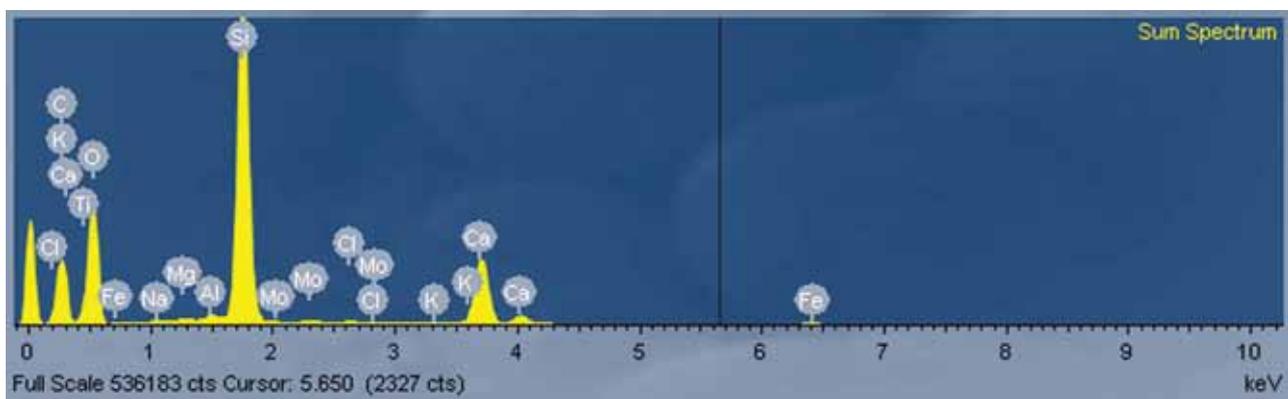
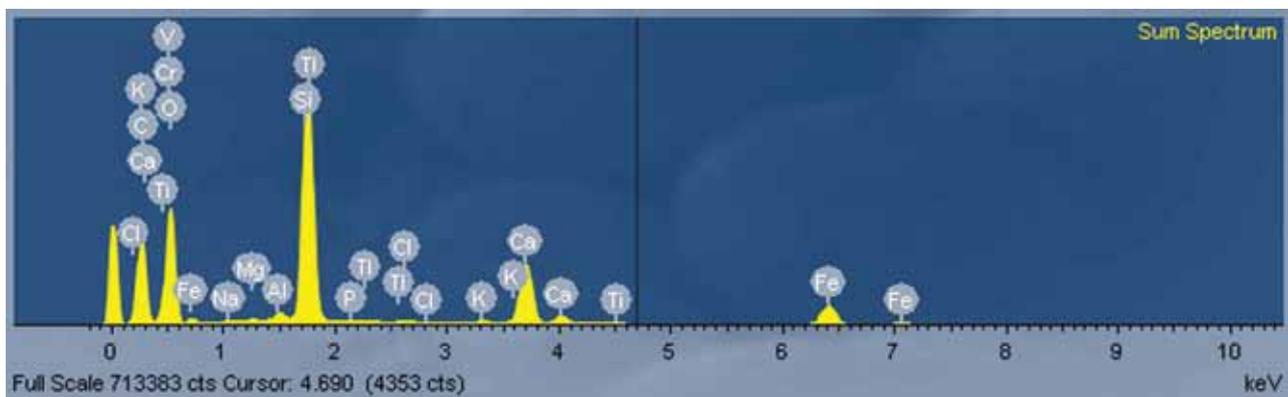
Fig. 19: Elemental composition of sample IV prepared at Dangeil.

Fig. 20: Elemental composition of sample X prepared at the British Museum.

Fig. 21: Elemental composition of sample IX prepared at the British Museum.

This can be compared with mortars prepared at the British Museum using the same recipes as in Sudan, but replacing the Sudanese lime with an hydraulic lime (**figure 20**, British Museum sample X) or a lime putty\* (**figure 21**, British Museum sample IX). These spectra show comparable levels of calcium to Sudanese mortar sample VI (**figure 19**).

Generally, the work carried out was successful; the local workmen had the manual dexterity to use the materials and were quick to learn their application. Scientific analyses have shown that the purchase of good quality lime is essential for the success of the capping. A great deal has been accomplished within the programme and with the limited choice of resources. If there has been one criticism of the project, it is that the appearance of the modern materials might be confused with some of the original ones. This is a debate for NCAM and the site directors. The project will continue to develop and there will be alterations to the methods and materials but these will not compromise the conservation of the archaeological remains.
